Manhole Inspection Summary

Manhole # S29AA1019MH

Insp Date: **12/13/06 9:05 AM**

Location Address: **720 36TH ST**

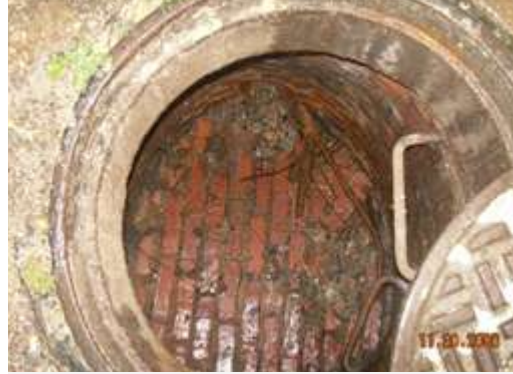
Top View

Corroded steps. Channel debris.

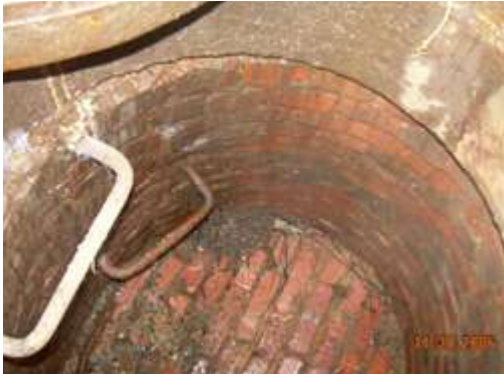
Defect

Frame Offset: **0** (in.) Condition: ☐ Sound ☐ Cracked ☒ **Leaks**

Condition: ☐ Sound ☐ Cracked ☐ Root Intrusion ☐ Loose Brick ☒ **Deteriorated**

Infiltration: ☐ None ☒ **Joint** ☐ Cracks ☒ **Mortar** ☐ Roots ☐ Wall

Frame leaks. Frame offset. Corbel deterioration and infiltration. Barrel infiltration.

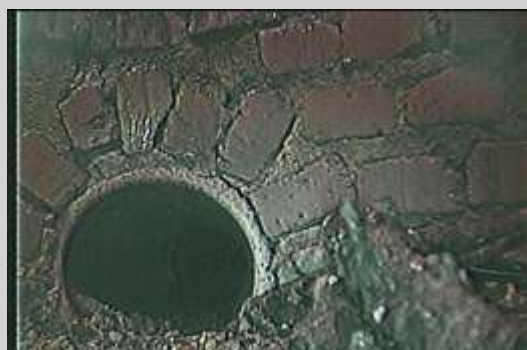
Pipe Out @ 12 O'Clock

Condition: ☐ Sound ☐ Cracked ☐ Root Intrusion ☐ Loose Brick ☒ **Deteriorated**

Infiltration: ☐ None ☐ Joint ☐ Cracks ☒ **Mortar** ☐ Roots ☒ **Wall**

Barrel deterioration and infiltration.
